SUSQUEHANNA RIVER BASIN  
WHITE OAK RUN, LACKAWANNA COUNTY

CURTIS DAM  
NDI ID NO. PA-00370  
DER ID NO. 35-17

APRIL 1979

(6) National Dam Inspection Program.  
CURTIS DAM  
(NDI ID, <sup>Number</sup> PA-00370  
DER ID <sup>Number</sup> 35-17)  
~~PENNSYLVANIA GAO AND INTERCOMPANY~~  
Susquehanna River Basin, White Oak Run,  
Lackawanna County, Pennsylvania.  
PHASE I INSPECTION REPORT  
NATIONAL DAM INSPECTION PROGRAM

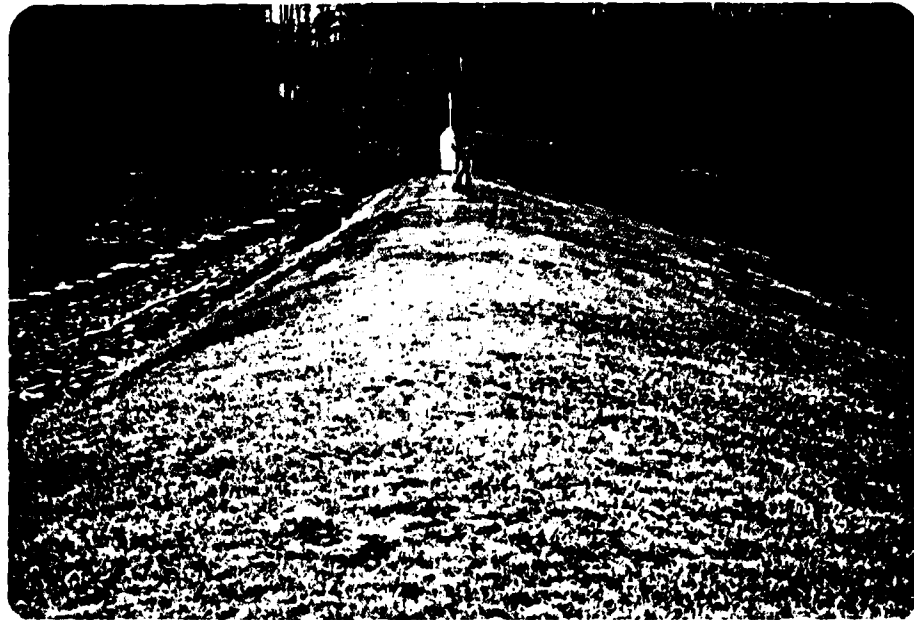
A. Top of Dam - from Right Abutment

b. Embankment. The embankment appears to be in good condition. The grass cover is in excellent condition. The upstream slope is swelled for an area 20 feet by 40 feet near the left end and about 10 feet below spillway crest elevation. A section through this area is shown on page B-11. Trail bike ruts extend up the downstream right abutment of the embankment. At the lower end of the trail bike ruts is a 4-foot square area of soil with its grass cover missing. Near the upper end of the trail bike ruts, near the top of dam, is a similar 10-foot square area. A drainage swale, which runs along the toe of the floodwall, extends down the right abutment. The riprap on the upstream slope is in good condition. The top of the riprap is about 3 feet below the design top elevation of the dam (Photograph C). There is a minor amount of brush along the top of the upstream slope. The survey performed for this inspection revealed that the upstream and downstream slopes are both 1V on 3H, except that the lower downstream slope is 1V on 6H. There are some low areas at the top of the embankment. The lowest area is 1.1 feet below the design elevation. This area appears to have been purposefully constructed low. It is adjacent to the intake structure (Photograph D). Other low areas occur along the floodwall and dike as described hereafter.

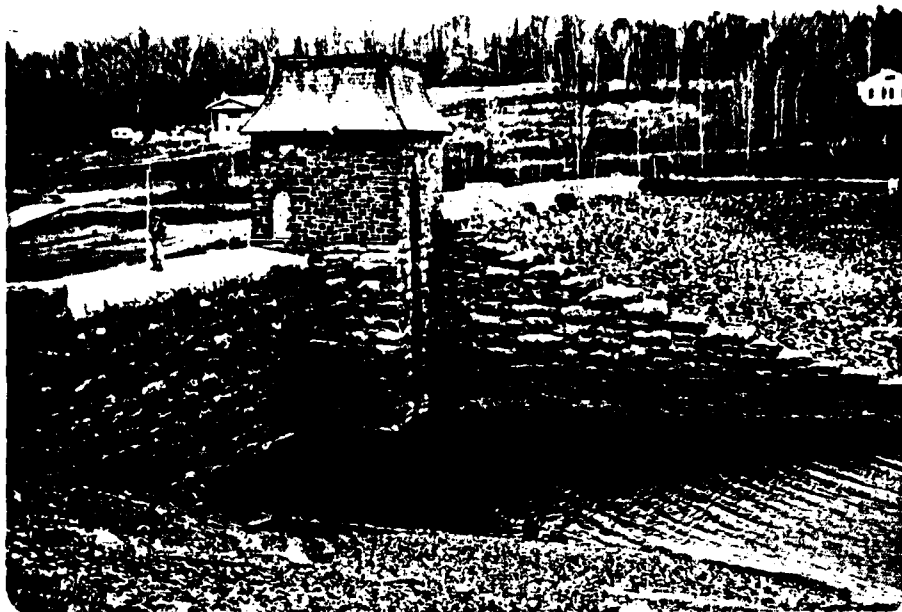
C. Spillway Approach and Upstream Slope

(2) Embankment. Brush on the embankment slopes and at the toe of the floodwall is undesirable. The swell on the upstream slope is believed to be caused by uneven grading during construction. If this is not the cause, it would be of concern. Trail bike ruts damage the embankment and create an erosion potential. The two areas with grass missing could have been wet areas. Because the pool was over 20 feet below the spillway crest elevation, no definitive conclusions concerning the seepage potential of the two areas noted above or the dam in general could be made during the visual inspection. The cause of the embankment slopes being flatter than the slopes shown on Plate 4 is unknown; this is not considered a deficiency. The low areas on the top of the embankment are probably caused by settlement, except for the low area near the intake structure, which is evaluated in Section 5.

(7) Monitor by any suitable means the swell on the upstream slope of the embankment. If changes are noted, take immediate remedial action.

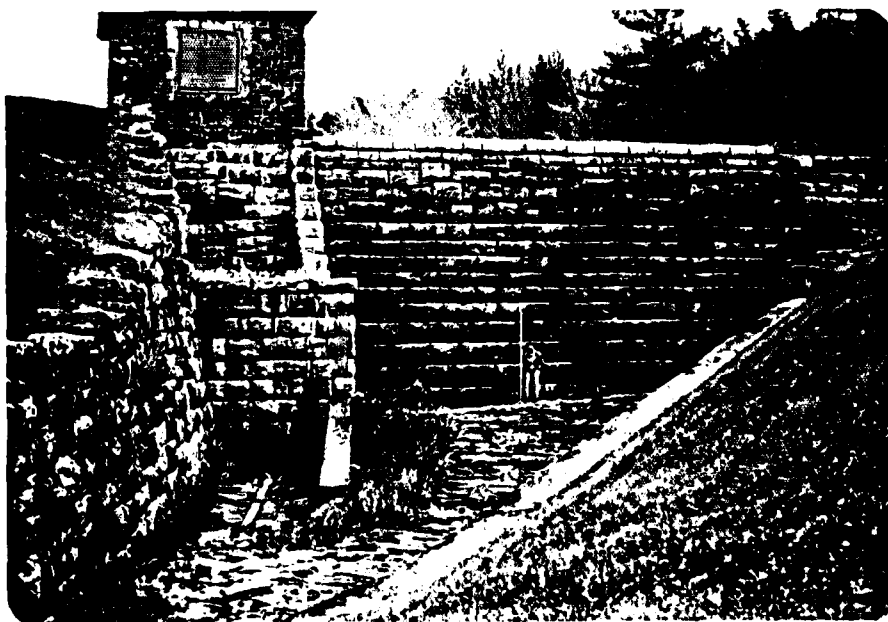
D. Spillway, Auxilliary Spillway, and Outlet Works

c. Appurtenant Structures. The outlet works appears in good condition. The outlet works valve was opened about 5 percent by two men in 10 minutes without any problems. The valve pit contained water. The caretaker reported that the pit is not drained. It appears that access to the pit would be hazardous during large spillway discharges. On the approach wall, upstream of the intake structure, a capstone is dislodged.

(3) Appurtenant Structures. No deficiencies were observed during the operation of the outlet works. Not draining the valve pit could hinder access to the valve. It may also allow the undrained water to freeze, thus damaging the valve. Although access to the valve pit may be hazardous during periods of high spillway discharge, this is not considered a deficiency because the outlet works discharge is negligible during a flood.

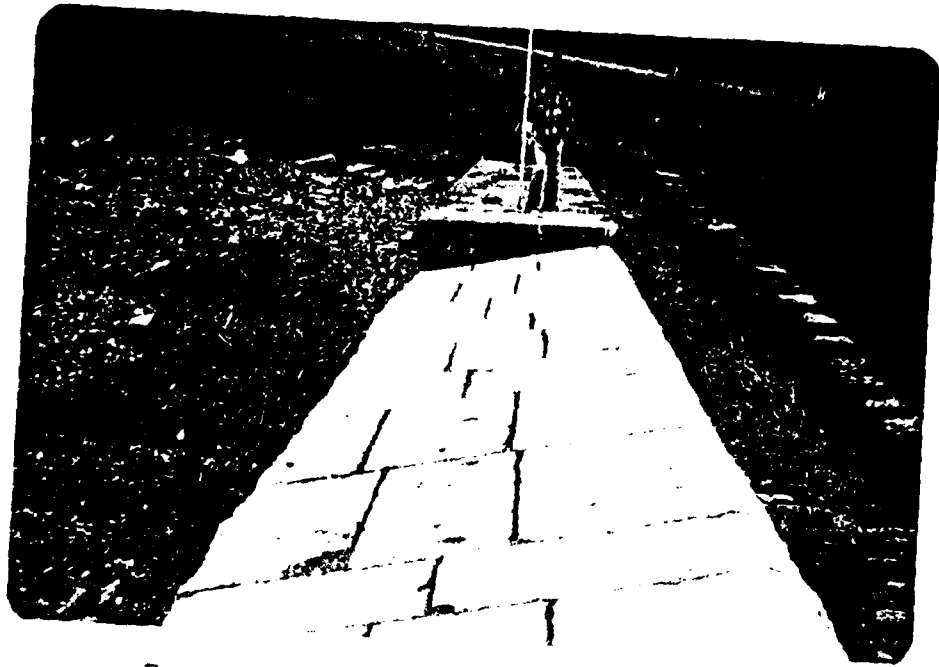
E. Main and Auxiliary Spillway Crest

The main spillway and the auxiliary spillway are in fair condition. The mortar on both spillways is deteriorated, and in some cases is missing almost completely. The condition is particularly severe on the uppermost 2 feet of the auxiliary spillway.

(3) Perform a study to ascertain the remedial measures required at the spillway area to correct deficiencies. This study should address the deteriorated mortar and concrete at the spillway, auxiliary spillway, auxiliary spillway apron, and spillway channel. The study should also address the structural stability of the left training wall, the hydraulic adequacy of the auxiliary spillway apron, and the scour potential beneath the downstream bridge. Take appropriate action as required. The section of wall lying in the spillway channel should be removed immediately. The study should be performed by a professional engineer, as noted above.

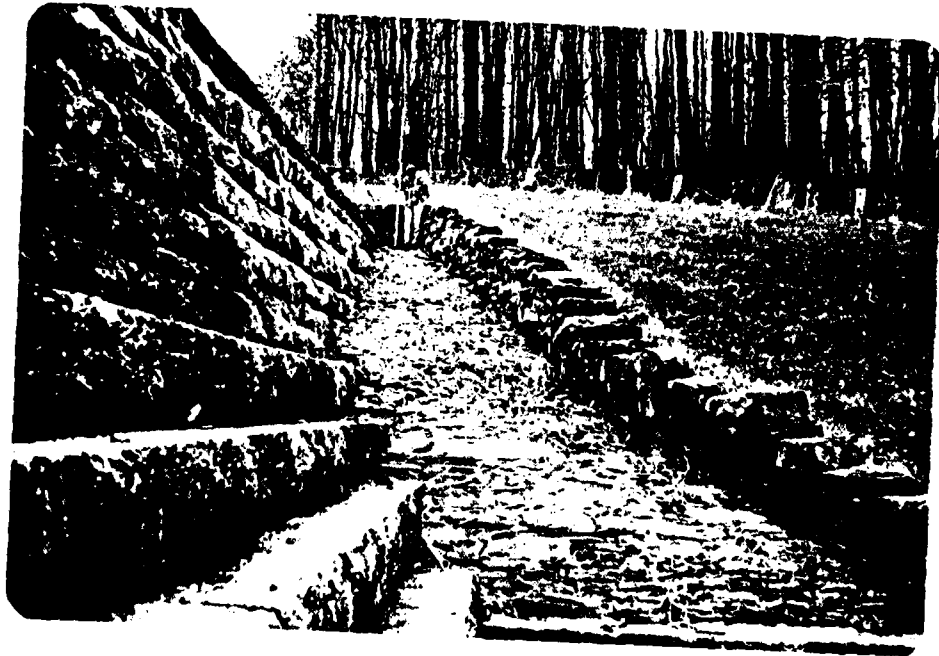
F. Auxiliary Spillway Apron

The auxiliary spillway apron and the spillway outlet channel are in poor condition. The mortar in the auxiliary spillway wall is deteriorated. The concrete (shotcrete) paving on the auxiliary spillway apron is almost completely eroded. The apron and wall do not appear to be of sufficient size to contain the auxiliary spillway discharge capacity. Relevant dimensions for this area are shown in Appendix B. Where the apron joins the spillway outlet channel, the concrete is severely scoured. The mortar between the paving stones on the bottom of the spillway outlet channel is about 95 percent eroded. The left spillway training wall is tilted. The entire wall exhibits peeling and pattern cracking. There is severe scour along the bottom of this wall; the largest single area scoured is 10 feet long and 1.5 feet deep (Photograph G). Near the downstream end of this channel, a 9-foot length of wall is offset. Immediately adjacent, another 9-foot length is lying on its side (Photograph H). There is some evidence of soil movement behind this section of the wall. The bridge at the downstream end of the channel has a scour hole on the bottom. The right training wall is leaching along its lower face. The capstones on the top of the wall show evidence of deterioration.

Most of the conditions in the main spillway, auxiliary spillway, and spillway channel are evaluated in Section 6. The dimensions of the auxiliary spillway apron and its associated wall are such that large discharges would either overtop the wall or shoot over the apron completely. This would be an erosion hazard. The length of wall lying in the spillway channel could restrict flow and raise the water surface sufficiently to pose an erosion hazard at the downstream toe of the embankment. The scour hole under the bridge is undoubtedly caused by the lack of channel paving under the bridge and by the deflection of the channel centerline at this point. The limits of the scour did not appear to be very extensive.

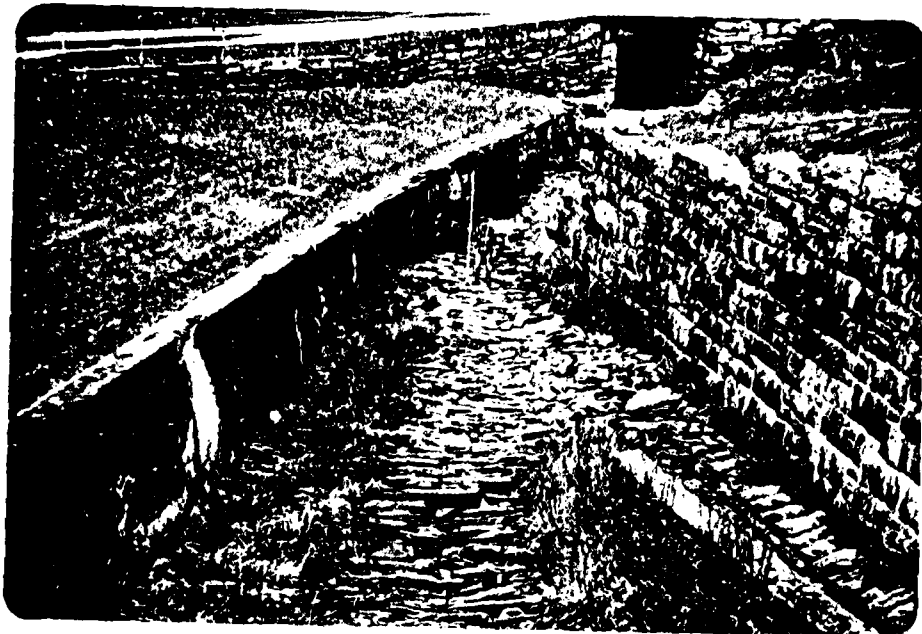
G. Spillway Channel

The conditions in the spillway, auxiliary spillway and their associated channels are mostly caused by lack of maintenance. The design of the spillway left training wall is addressed hereafter. The possible slope movement behind this wall is undoubtedly caused by the failure of the wall. Movement of this slope is not an immediate hazard to the dam. It may eventually encroach upon the spillway channel. It might also present a hazard to the bridge at the
